The Hull-to-Deck Joint

A Critical Look at
This Often Under-rated
Element of Boat Quality

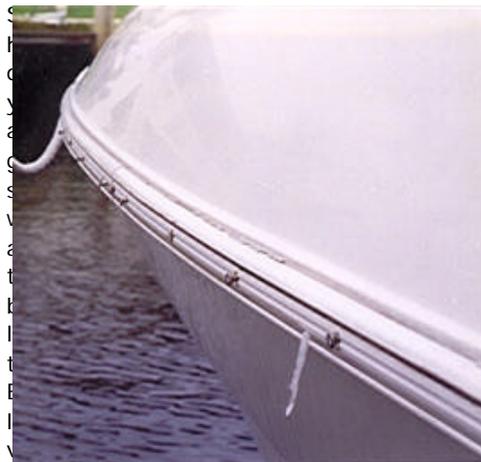
Could a picture be any more convincing than this one? Notice how every screw is backed out. A couple have fallen out completely.

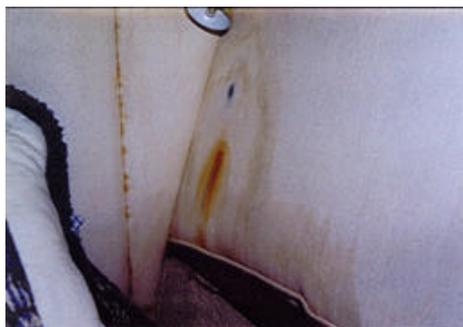
This is typical of the kind of interior damage that occurs from leaking deck joints.
